THE INVESTIGATION OF DERAILMENTS

December 2023

INDIAN RAILWAYS INSTITUTE OF CIVIL ENGINEERING
PUNE 411001

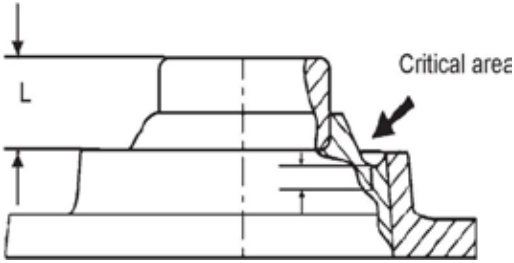
Fig. 5.29 Damage to Lateral Bump Stop

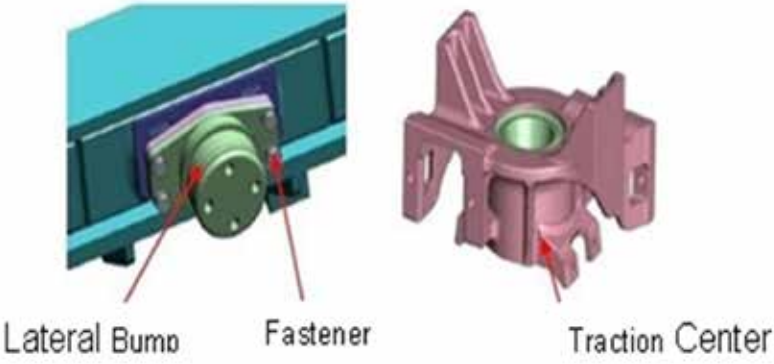
Fig. 5.29 Damage to Lateral Bump Stop

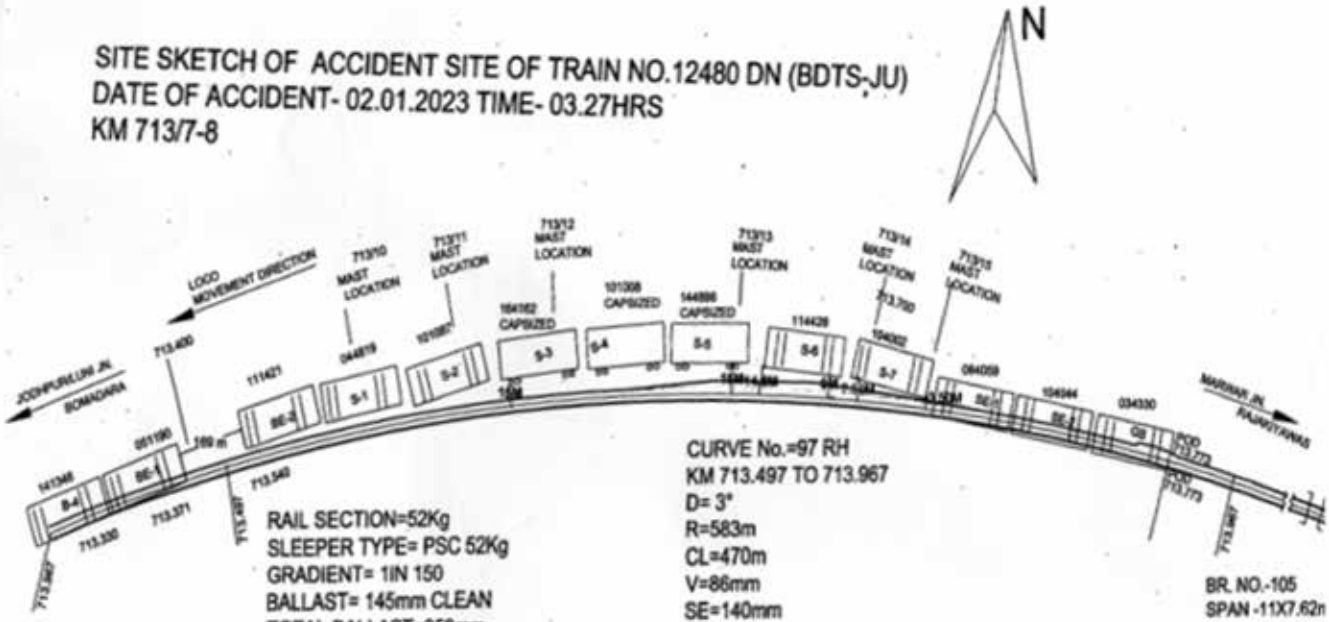
Train No. 12480 BDS-JU Superfast, known as Suryanagari SF Express, commenced its journey from BDTS on 01/10/2023. The train reached Marwar Junction at 02:50 hrs on 02/01/2023, its official stop. Departing at 03:06 hrs (delayed by 01 minute), it derailed at location 713/8-7 at 03:27 hrs, All derailed coaches went on the right side, the outer side of the 3˚ curve, with severe damage to underframes and suspension components of derailed coaches

The North Western Railway identified "Rail Fracture" as the prima facie cause of the derailment. Track measurement behind the fracture was impeded due to fully smashed sleepers and dislocated rail on the outer side of the curve.

The fracture of the rail and the failure to detect the transverse flaw in the rail (which was in a grown-up state) during the last Ultrasonic Flaw Detection (USFD) on 24/12/2022 are the reasons responsible for the accident.

There were multiple rail fractures in the right hand side rails after point of drop for first 5 -6 metres. So, a total of 12 broken rail pieces and 2 broken pieces of bolt with intact nut, 1 damaged fish

RDSO in their report mentioned that metallurgical properties of the rail conform to relevant specifications for the conducted tests. The failure of the rail in fatigue mode at locations 'A,' 'B,' and 'D' (shown in above figure) may be attributed to fatigue cracks initiated from the subsurface of the gauge face side below the rail table due to the presence of severe shear cracks on the rail table. Non-metallic inclusions further aggravated the rail fracture at location 'A'. Failures of remaining components could be consequential effects of rail breakage. Fatigue defects could have been detected during the last USFD testing as per the Manual for Ultrasonic Testing of Rails & Welds Revised – 2022.

1. All track stretches with "D" marked rails should be scanned out of turn by a B-Scan machine.
2. Replace all USFD machines, including DRT and SRT, with B-scan

3. Implement a proper system to preserve continuous scanning records of B-scan through TMS.
4. Check whether similar conditions exist throughout "D" marked rails.
5. Assess the residual fatigue life of "D" marked 52 kg rails through scientific testing.
6. Prescribe a higher frequency of USFD testing for "D" marked rails.
7. Introduce rail grinding, especially on "D" marked rail, with predefined frequency and extent.
8. Implement scrutiny of inspections by supervisors, including SSE (PWay), AEN, Sectional DEN, Sr. DEN (Co), THOD, CTE, etc

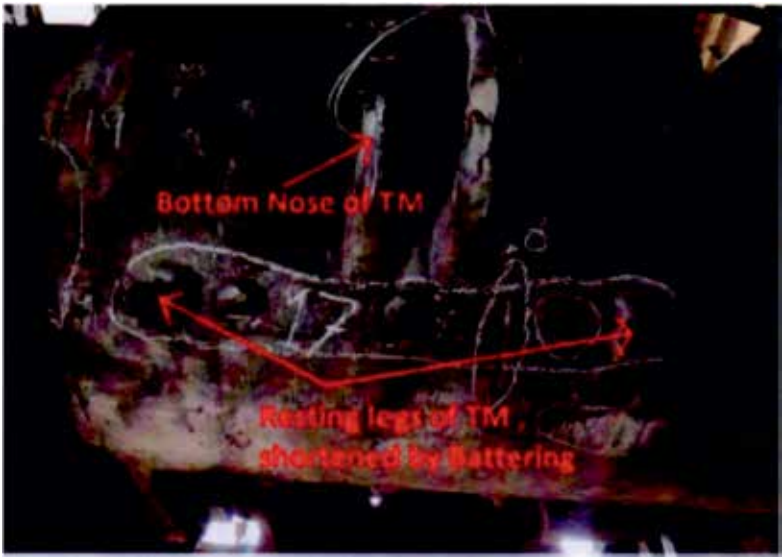
Fig. 1- Condition of Resting legs of TM-2

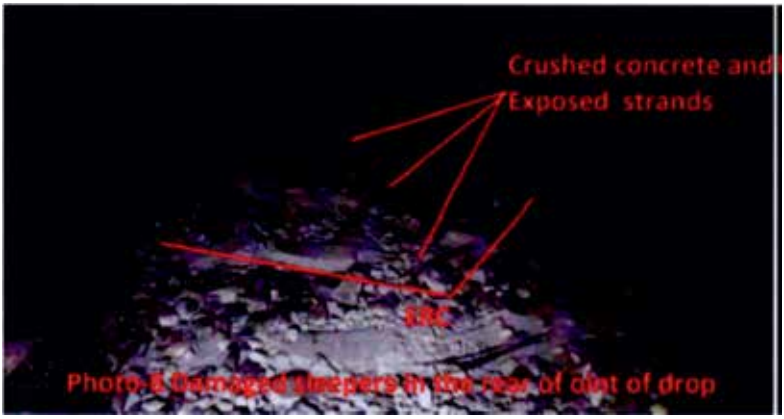
Fig. 2- Damaged Sleeper before point of drop

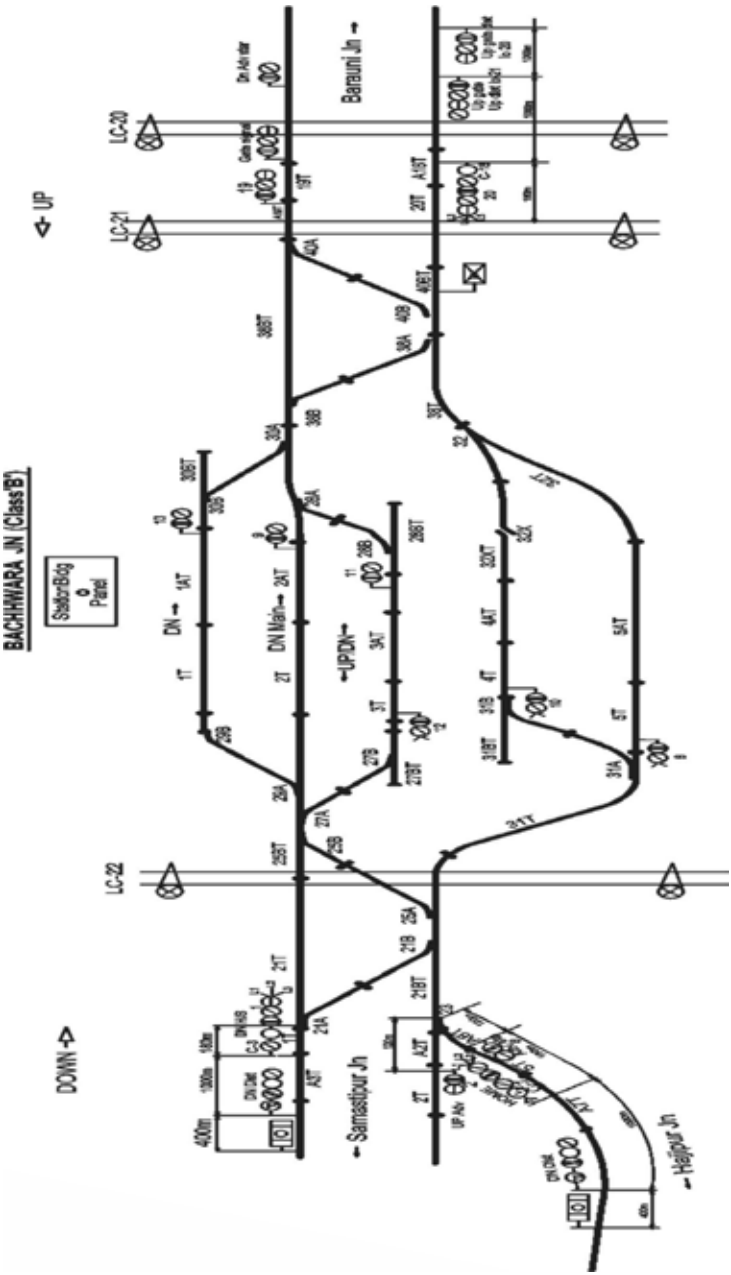
Fig. 9.3 (a) Bachchawara Junction

SWRD of Bachhwara Jn showing the Track circuits and Signals is shown in Fig. 9.3. (a) and (b) Output of the Data Logger at Bachhwara for the relevant period and interpretation of the data is placed in Table 9.1 and 9.2

during the movement of the train over it. This type of changeover of position of point 23 cannot happen in normal course of working. As per the circumstantial evidence, it was suspected that there was mismanagement in operation of Point no 23 during the run of the train.

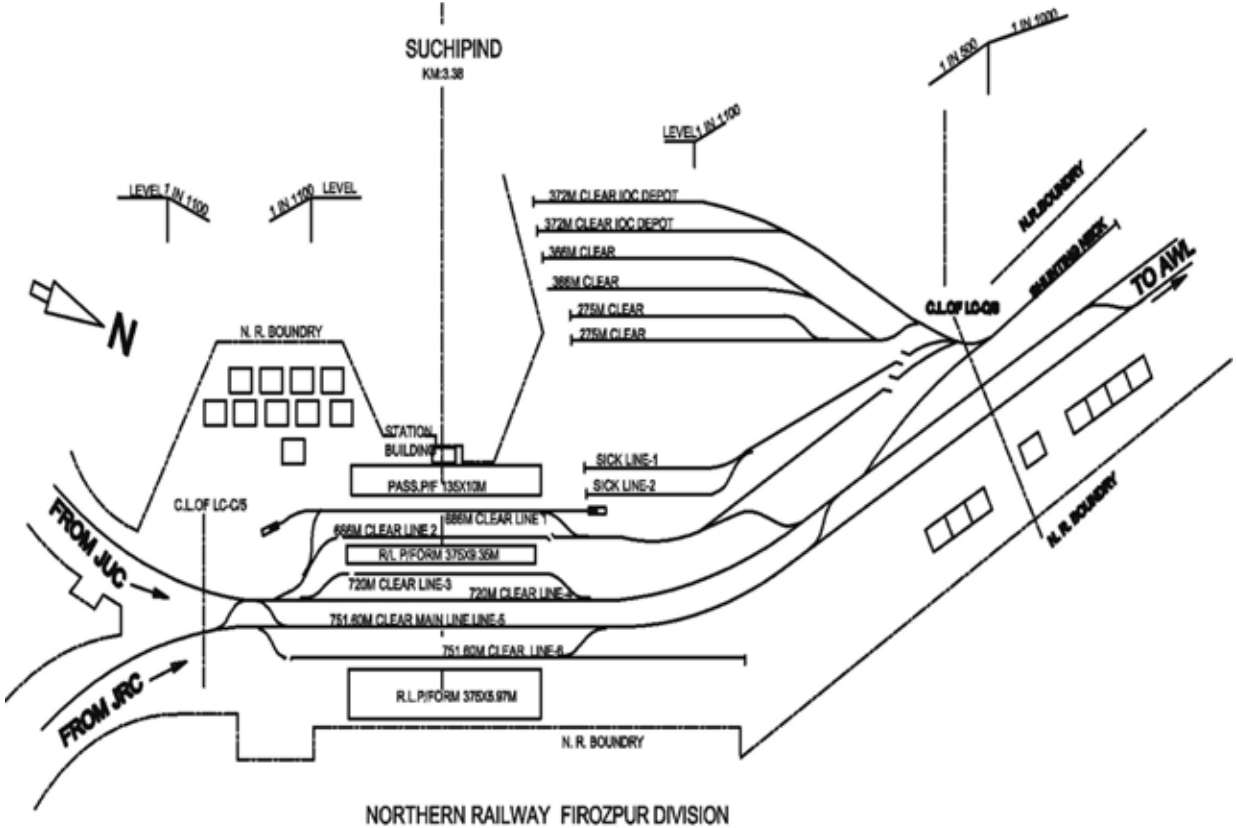
Report of Sr.DSTE/FZR: SCPD station has standard III Route Relay Interlocking with 102 routes. The station RRI was taken over by Open Line from Construction on 8.3.2007. He had noted on arrival at site that the Emergency Key of ESM was out. He has further stated that the route set for line no.5 for this train was cancelled. Later on, route was set for line no.2 for this train and again the route for line no.2 was cancelled by emergency button which caused movement of point number 135-B for line No.1, thus, creating two roads situation while the train was crawling on the point no. 135-B.

Sr.DSTE further stated that the construction organization did not test the last 14 routes, including Calling on routes of signal 160 A, B, in the selection table, and this was not signed by officer in-charge. Moreover, normal cancellation by station master was not working and route of line no.1 and 2 did not get released after arrival of train. These defects were neither recorded nor reported in Signal Failure Register.

Data Logger Report: This indicated that EUUYNPR & EUUYNR relays were operated at 00.09.52:859 and 00:09:52:875 respectively on 11.03.2011, and 2 seconds after this operation, feed was extended to point no. 135 for its operation from N to R. The cross over point 135 operated at 00:09:58:158. Thus, with this operation of point, Two Road condition was created.
